# REPORT ON SPECIAL PURPOSE HYDROGRAPHIC (BATHYMETRIC AND SIDESCAN) SURVEY

PROJECT: Project Conditions Hydrographic (Bathymetric) Survey for Crowley

Terminal at San Juan Bay, Municipality of San Juan, Puerto Rico

PROJECT: JEB 5216

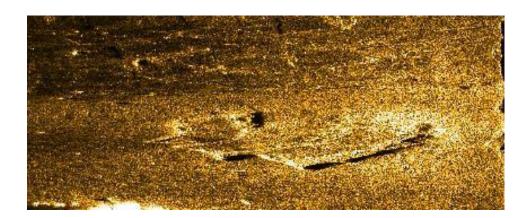
Notes	Unknown Object

Anomalies and acoustic shadows may indicate submerged obstructions. Diving inspection is recommended for all designated targets. Please see attached hydroghaphic drawing for depth and target locations. Raw imagery and associated sidescan files and this document are hereby made part of each other by reference and not valid if separated from each other.
